Infrared thermography detects potentially unsafe, costly bushing hot spot

SDMyers utilizes infrared (IR) scanning, an effective complementary analytical method, to help a New York-based industrial customer identify a faulty, high voltage connection and complete a safe, scheduled replacement.

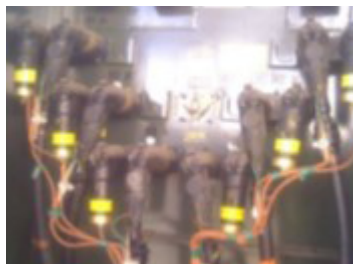
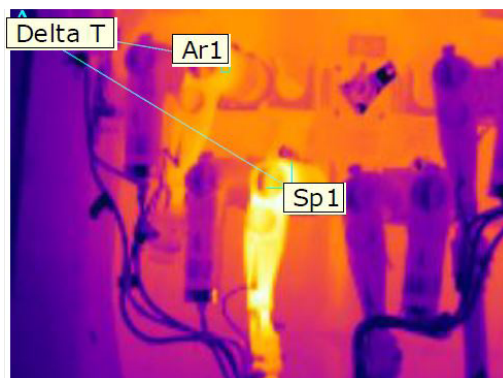
When the thermographer performed the IR inspection, he found deficiencies not evident during the visual inspection. The IR images showed that one of the A side loadbreaks was experiencing a significant temperature difference of 19°C when compared to the other phases. Dissolved gas analysis (DGA) confirmed the IR thermography findings by showing high levels of ethylene and acetylene in the dielectric liquid, indicating the high temperature was potentially affecting the internal connection. SDMyers recommended monitoring the connection moving forward. However, the following year, IR thermography revealed that the hot spot had persisted, along with elevated levels of dissolved gas.

A SIDE BUSHING — A COMPARISON OF CONVENTIONAL PHOTOGRAPHY AND A THERMAL IMAGE SHOWING A DELTA OF 19.3°C BETWEEN SP1 (46.3°C) AND AR1 (27.0°C).

After completing a cost analysis on field repair versus replacement, replacing the transformer emerged as the better solution for this customer. SDMyers continued with liquid sampling and IR scanning to monitor the loadbreak and bushing while planning and procurement were underway. The IR scanning, combined with the liquid test data and ongoing monitoring, allowed the customer to:
