# Infrared thermography detects potential cooling system problem

During a routine transformer inspection, SDMyers performs infrared (IR) scanning, an effective complementary analytical method, to help a Michigan-based utility company avoid downtime.

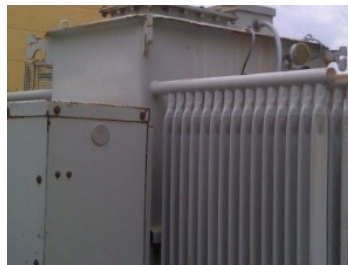
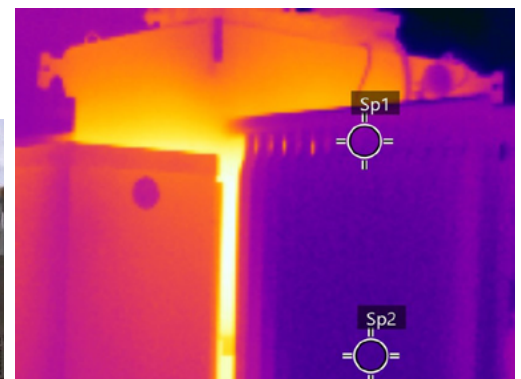
During the IR inspection, the thermographer identified a problem in one of the radiator banks, the unit's main cooling system. Instead of showing a smooth, decreasing temperature gradient from top to bottom, indicating proper operation, the thermal image indicated that the entire radiator bank was cool.

This is usually an indicator of a low liquid level and is something that cannot be seen from liquid sampling. Although this type of deficiency is normally identified during the visual inspection of the level and temperature gauges, the situation was complicated by the fact that both gauges were showing irregular fluctuations year to year and season to season. This led to the conclusion that one of the gauges was faulty and would need to be replaced.

TRANSFORMER RADIATOR — A COMPARISON OF CONVENTIONAL PHOTOGRAPHY AND A THERMAL IMAGE SHOWING THE LACK OF A TEMPERATURE GRADIENT WITH ONLY A DELTA OF 0.6°C BETWEEN SP1 (22.4°C) AND SP2 (21.8°C).

By utilizing IR thermography, this customer was able to confirm that the liquid level was low (even with a possible gauge problem) and the radiator was not cooling the liquid as it should. In addition to collecting the data needed to justify a liquid top-off service and gauge replacement, the customer was able to prevent:
